# **INDOOR AIR QUALITY ASSESSMENT**

**Samoset Middle School  
100 DeCicco Drive  
Leominster, Massachusetts**

Prepared by:  
Massachusetts Department of Public Health  
Center for Environmental Health  
Emergency Response Indoor Air Quality Program  
September 2005

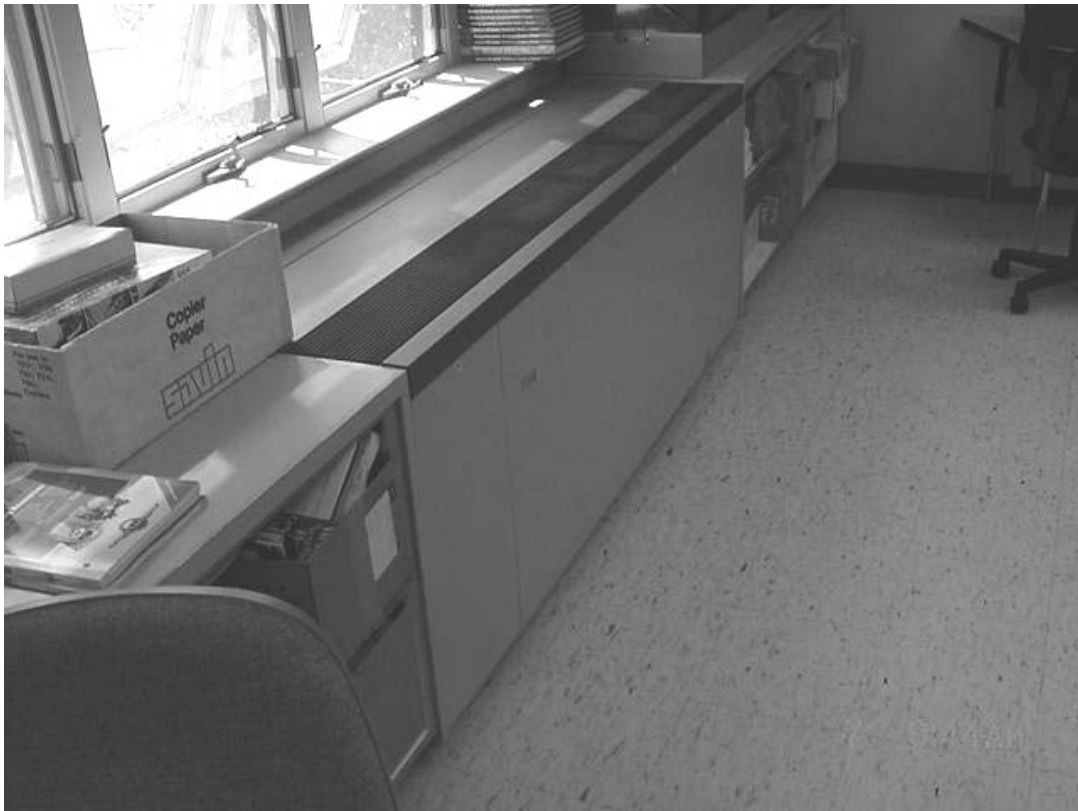
**Picture 1**

Fresh air in exterior classrooms is supplied by a unit ventilator (univent) system equipped with high efficiency pleated filters (Pictures 1 and 2). Univents are designed to draw air from outdoors through a fresh air intake located on the exterior walls of the building (Picture 3). Return air is drawn through an air intake located at the base of each unit ([Figure 1](#)). Fresh and

**Typical Classroom Univent**

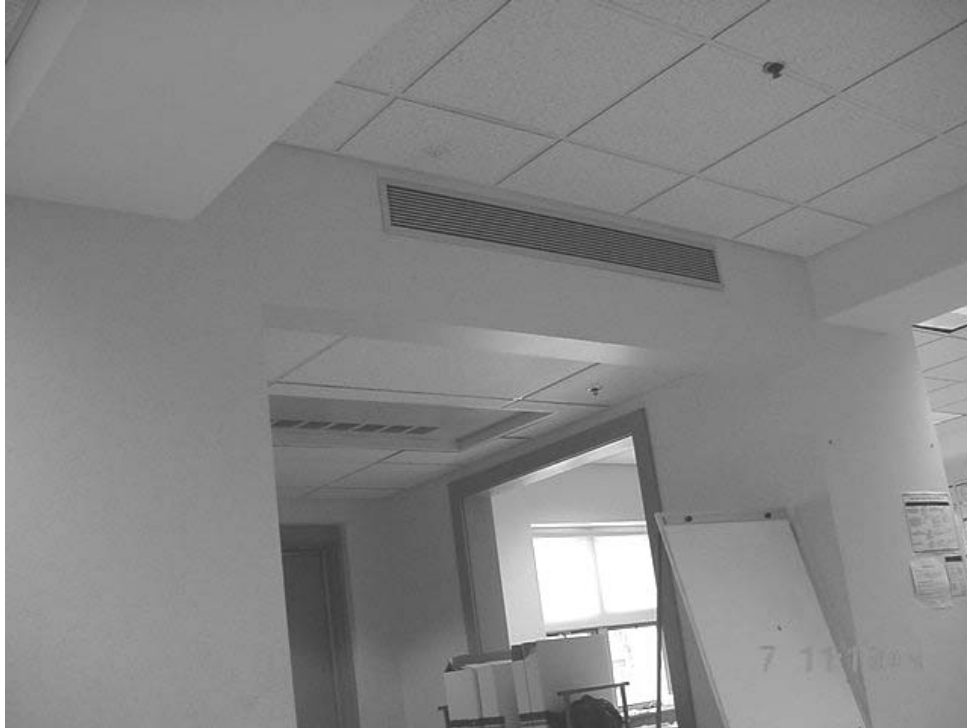
**Picture 2**

**Ceiling-Mounted Univent in First Floor Classroom**

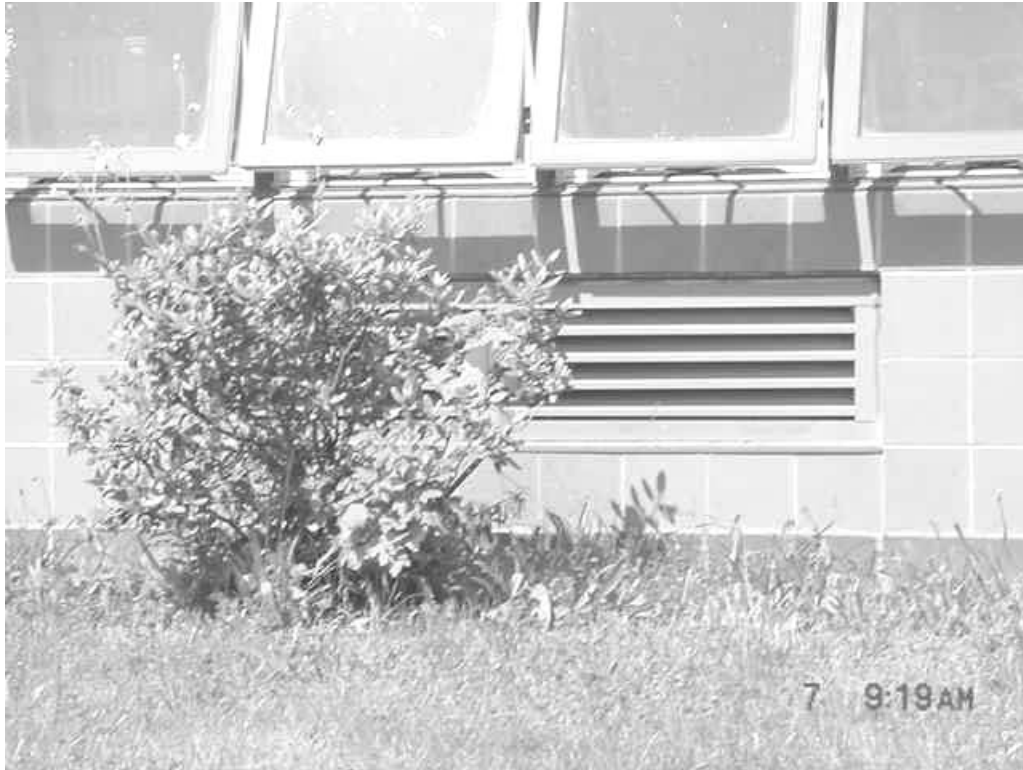
**Picture 3**

Plants were noted in several classrooms, and shrubbery was seen in close proximity to univent air intakes (Pictures 3 and 10). Plants can be a source of pollen and mold, which can be respiratory irritants for some individuals. Plants should be properly maintained and equipped with drip pans. Plants should also be located away from ventilation sources (e.g., air intakes, univent diffusers) to prevent the entrainment and/or aerosolization of dirt, pollen or mold.

**Univent Fresh Air Intake, Note Plant Growth in Close Proximity**

8. Clear plant growth away from the proximity of univent air intakes.

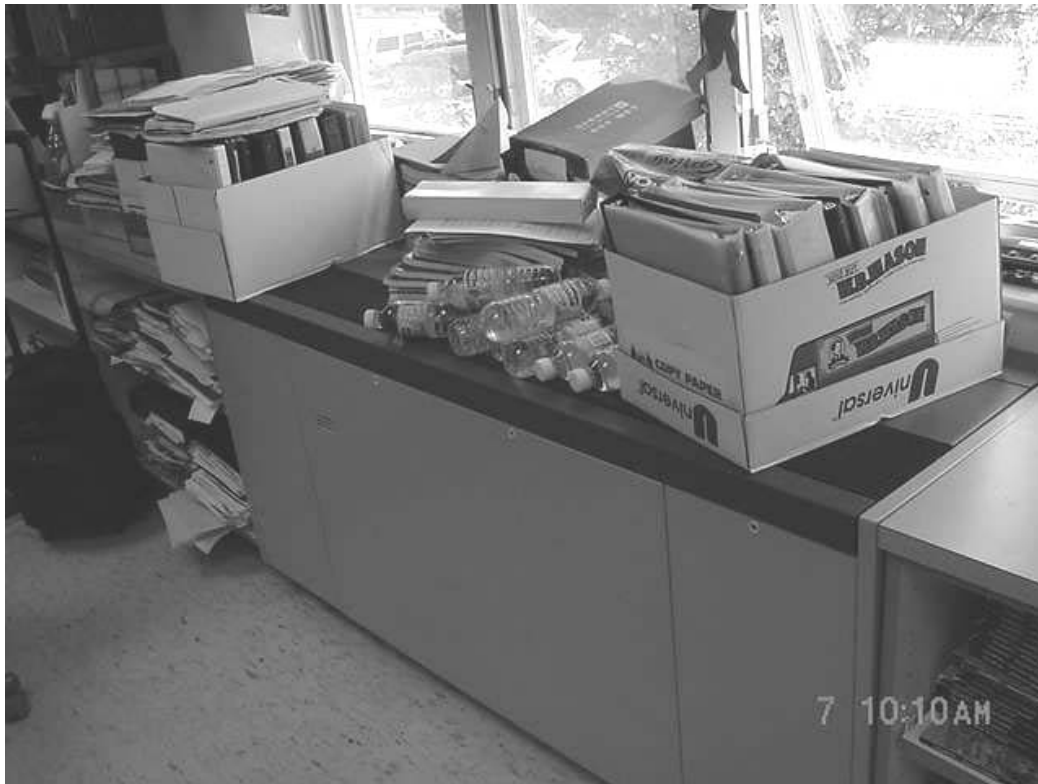
**Picture 4**

return air are mixed, filtered, heated and provided to classrooms through an air diffuser located in the top of the unit. All univents were operating during the assessment; however obstructions to airflow, such as papers and books stored on univents and bookcases, carts and desks in front of univent returns, were seen in a few classrooms (Picture 4). In order for univents to provide fresh air as designed, units must remain free of obstructions.

**Univent Air Diffuser Obstructed by Various Items**

3. Remove all blockages from univents and exhaust vents to ensure adequate airflow.
4. Close classroom doors to maximize air exchange.
5. For buildings in New England, periods of low relative humidity during the winter are often unavoidable. Therefore, scrupulous cleaning practices should be adopted to minimize common indoor air contaminants whose irritant effects can be enhanced when the relative humidity is low. To control for dusts, a high efficiency particulate arrestance (HEPA) filter equipped vacuum cleaner in conjunction with wet wiping of all surfaces is recommended. Avoid the use of feather dusters. Drinking water during the day can help ease some symptoms associated with a dry environment (throat and sinus irritations).

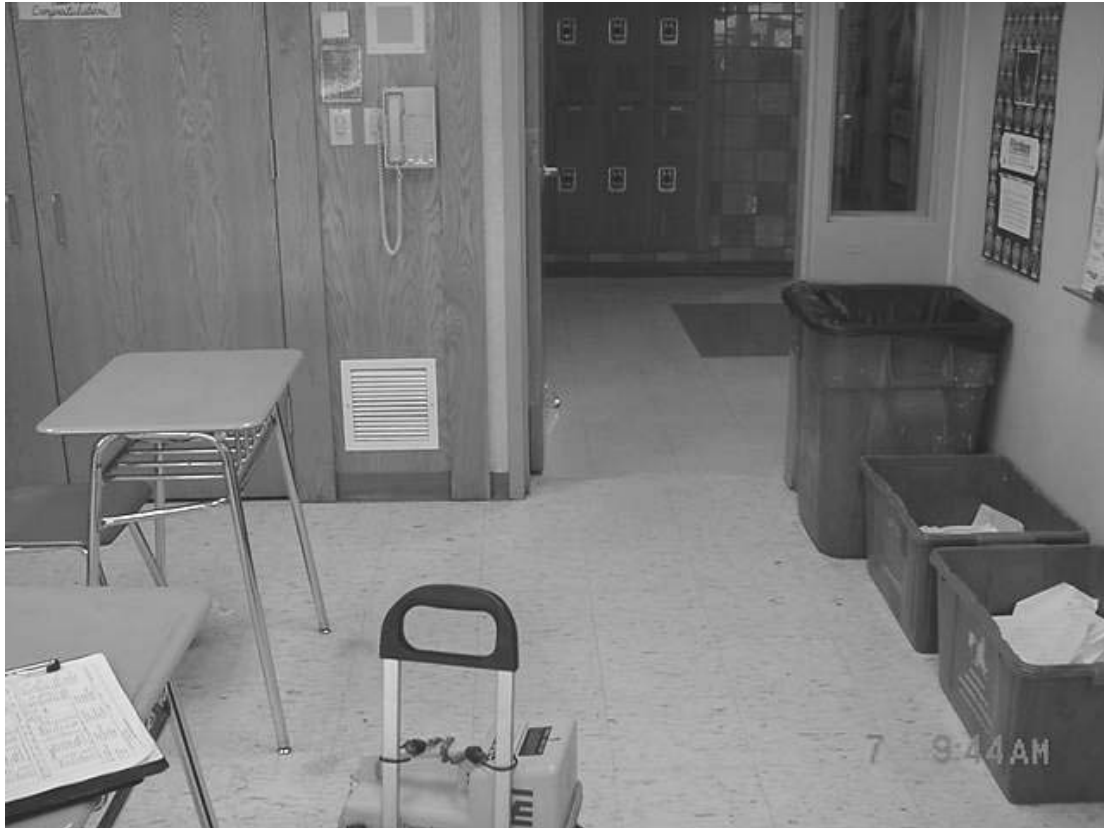
**Picture 5**

Exhaust ventilation in classrooms is provided by wall-mounted vents powered by rooftop motors (Picture 5). Exhaust vents did not appear to be functioning in a number of classrooms in the two-story wing (Table 1), which can indicate that motors were deactivated or non-functional. A number of exhaust vents were also obstructed by desks, bookcases and other items (Picture 6). As with the univents, in order to function properly, exhaust vents must be activated and remain free of obstructions. In addition, the location of some exhaust vents can limit exhaust efficiency. In several rooms, exhaust vents are located near hallway doors (Picture 5). With hallway doors open, exhaust vents in these rooms will tend to draw air from both the hallway and the classroom, reducing the effectiveness of the exhaust vent to remove common environmental pollutants.

**Classroom Exhaust Vent, Note Open Hallway Door**

1. Work with an HVAC engineer concerning the operability of rooftop exhaust vents in the two-story wing.
2. Use openable windows in conjunction with classroom exhaust vents to facilitate air exchange. Care should be taken to ensure windows are properly closed at night and weekends to avoid the freezing of pipes and potential flooding.

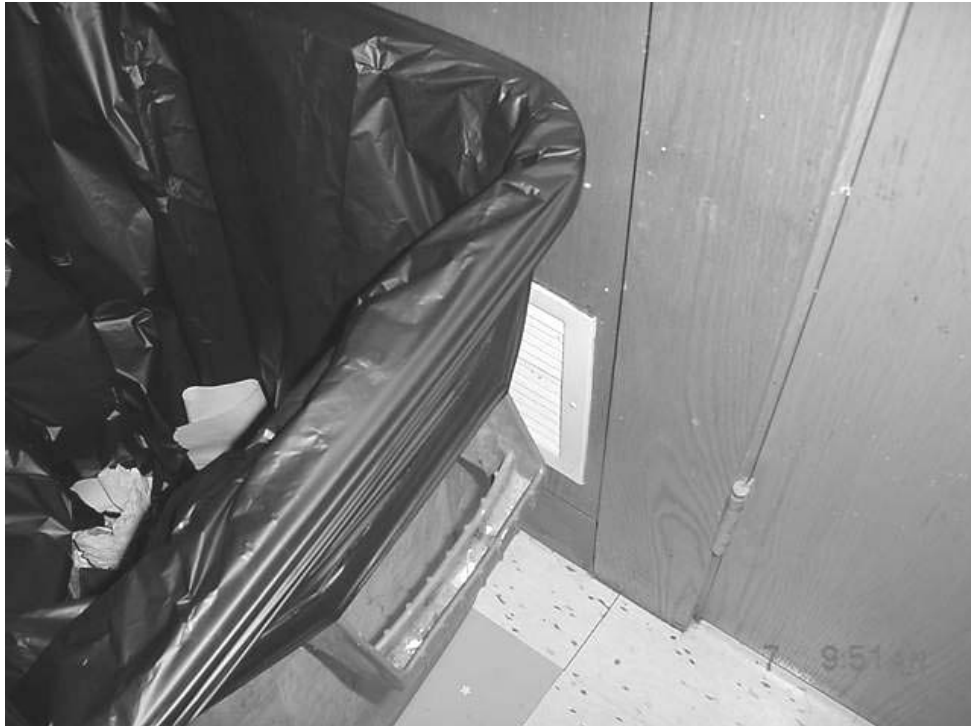
**Picture 6**

**Exhaust Vent Obstructed by Trash Barrel**

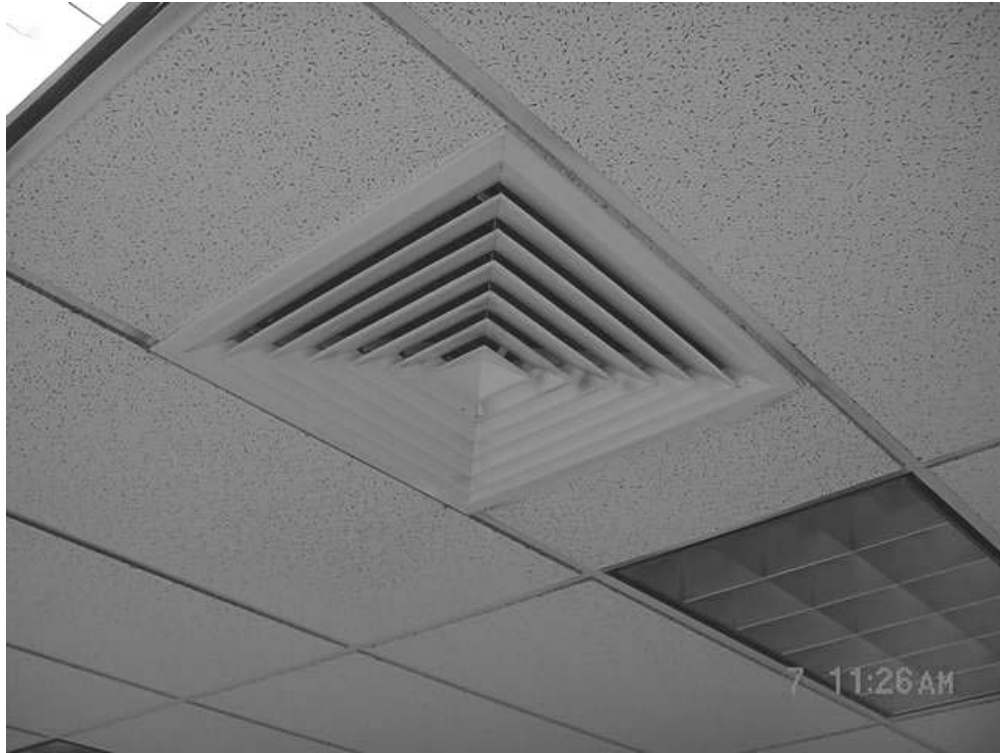
**Picture 7**

**Ceiling-Mounted Multi-Directional Air Diffuser**

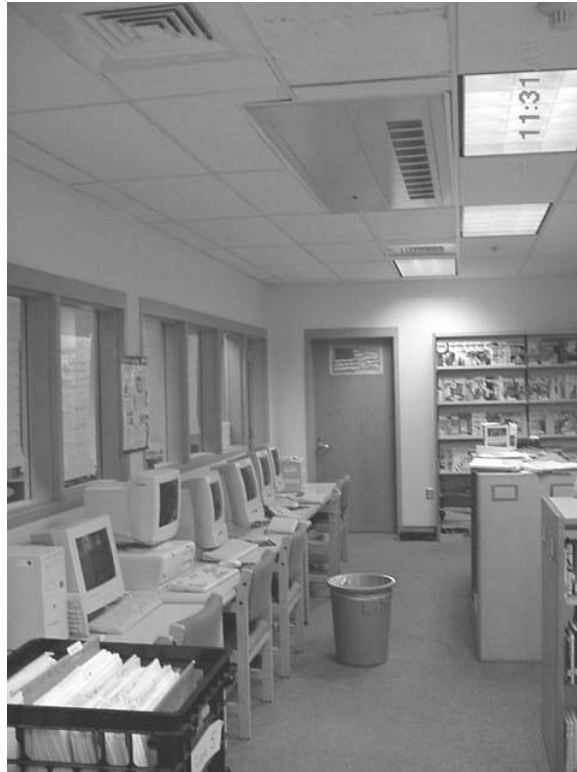
**Picture 8**

The ceiling-mounted air conditioning (AC) unit in the library has experienced leaks due to condensation (Picture 8). Occupants reported that the school's HVAC vendor had been in the

building several days prior to the MDPH assessment to repair the AC unit. The carpeted area beneath the AC unit had signs of water damage. To determine if the carpeting had been thoroughly dried, CEH staff performed moisture testing of carpeting directly beneath the AC unit. As indicated, moisture content was measured with a Delmhorst Moisture Detector equipped with a Delmhorst Standard Probe. The Delmhorst probe is equipped with three lights that function as visual aids that indicate moisture level. Readings that activate the green light indicate a sufficiently dry or low moisture level, those that activate the yellow light indicate borderline conditions and those that activate the red light indicate elevated moisture content. No elevated moisture readings were measured during the assessment (Table 1).

**Bucket Stationed beneath Leaking AC Unit in Library**

6. Ensure leaks are repaired, and replace water damaged ceiling tiles. Examine the area above and around these areas for mold growth. Disinfect areas of water leaks with an appropriate antimicrobial. Particular attention should be made to water damage in the library (e.g., ceiling tiles and carpeting).

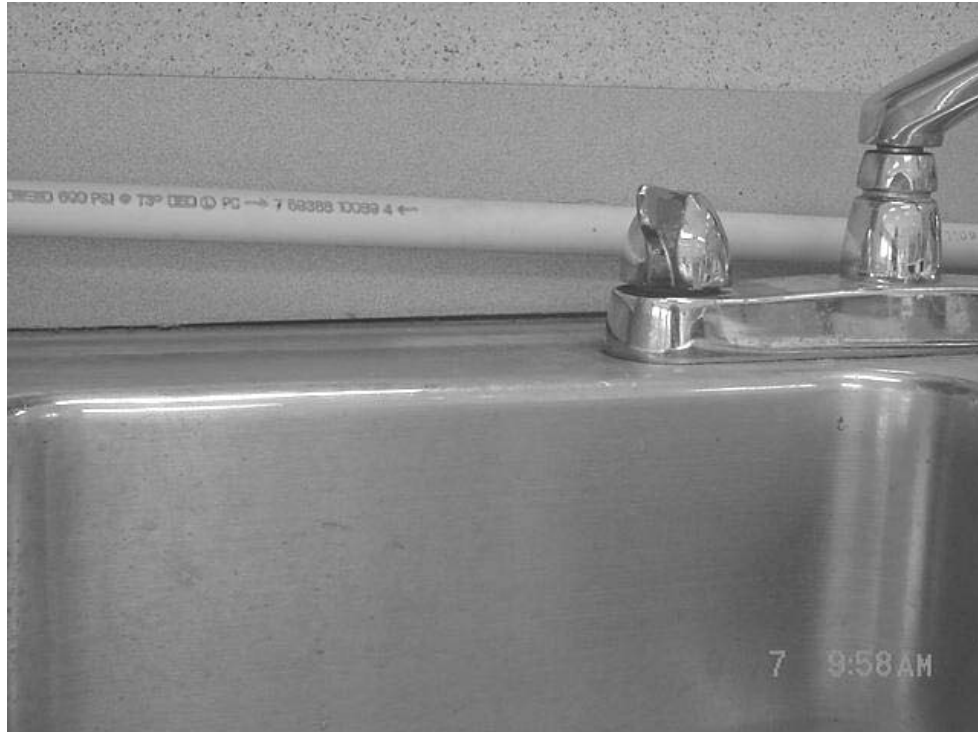
**Picture 9**

**Breach between Sink Countertop and Backsplash**

9. Clean and maintain aquariums and terrariums to prevent mold growth and associated odors.
10. Seal areas around sinks to prevent water damage to the interior of cabinets and adjacent wallboard.

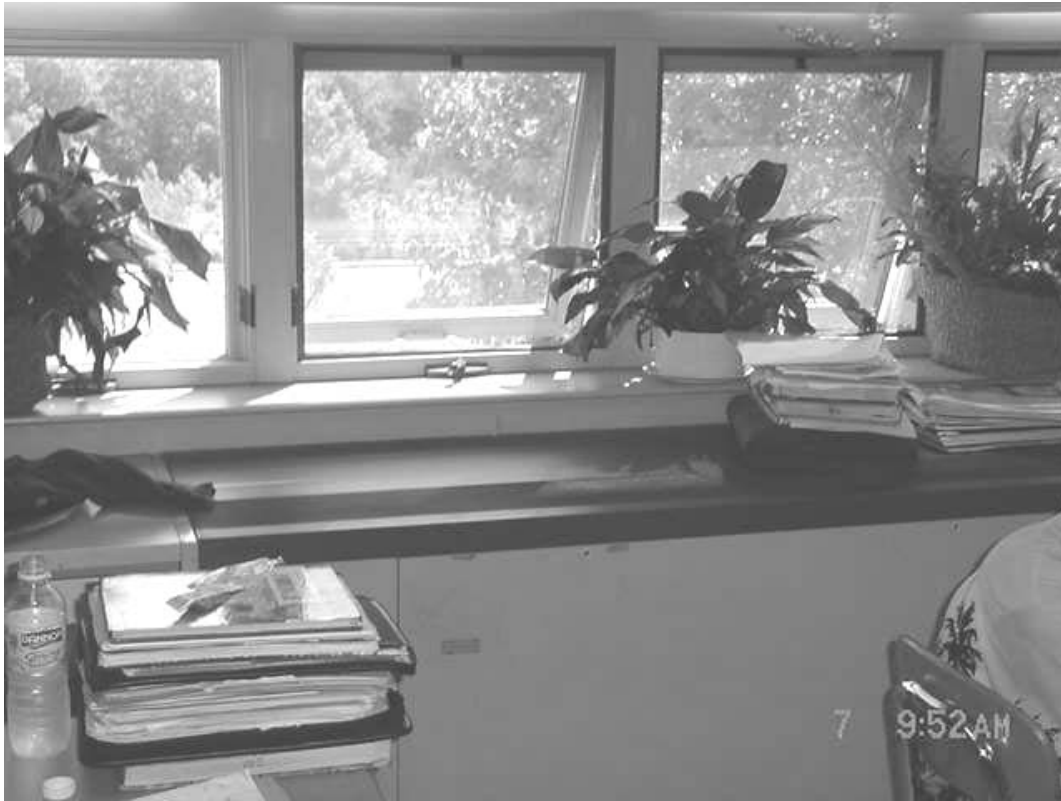
**Picture 10**

**Plants Near the Airstream of Univents**

7. Ensure plants have drip pans. Examine drip pans periodically for mold growth and disinfect with an appropriate antimicrobial where necessary. Remove plants from the air stream of univents.

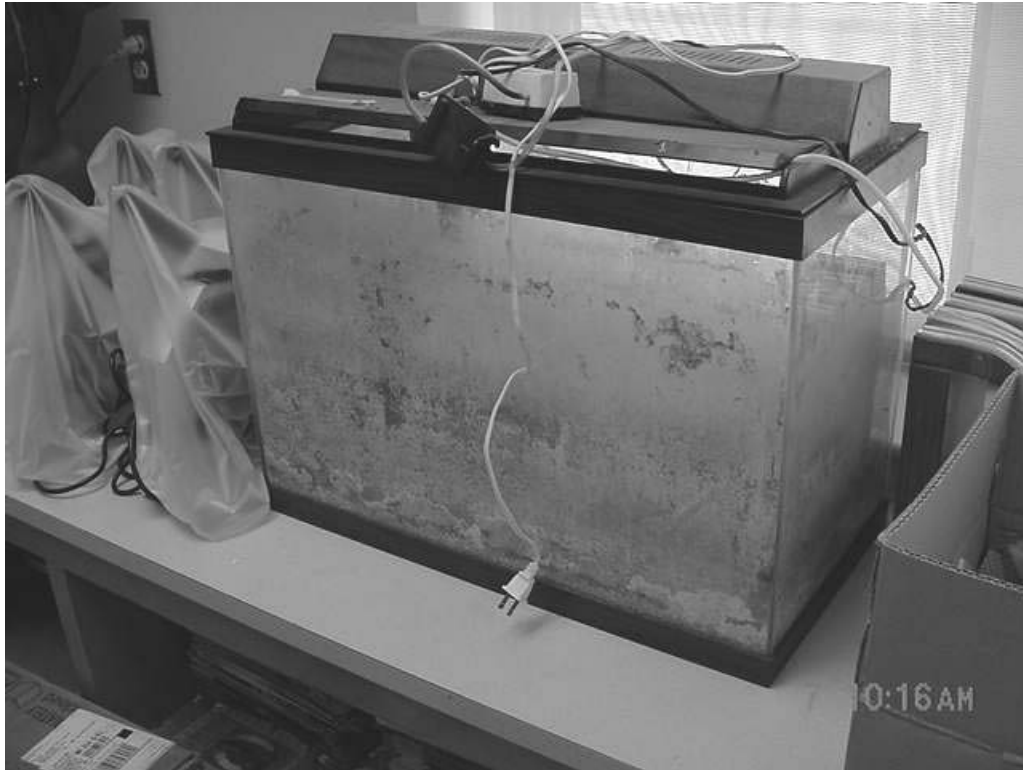
**Picture 11**

A number of aquariums and terrariums were observed in classrooms (Picture 11). Aquariums should be properly maintained to prevent microbial/algae growth, which can emit

unpleasant odors. Similarly, terrariums should be properly maintained to ensure soil does not become a source for mold growth.

**Empty Aquarium in Classroom with Algae/Mold Growth Interior**

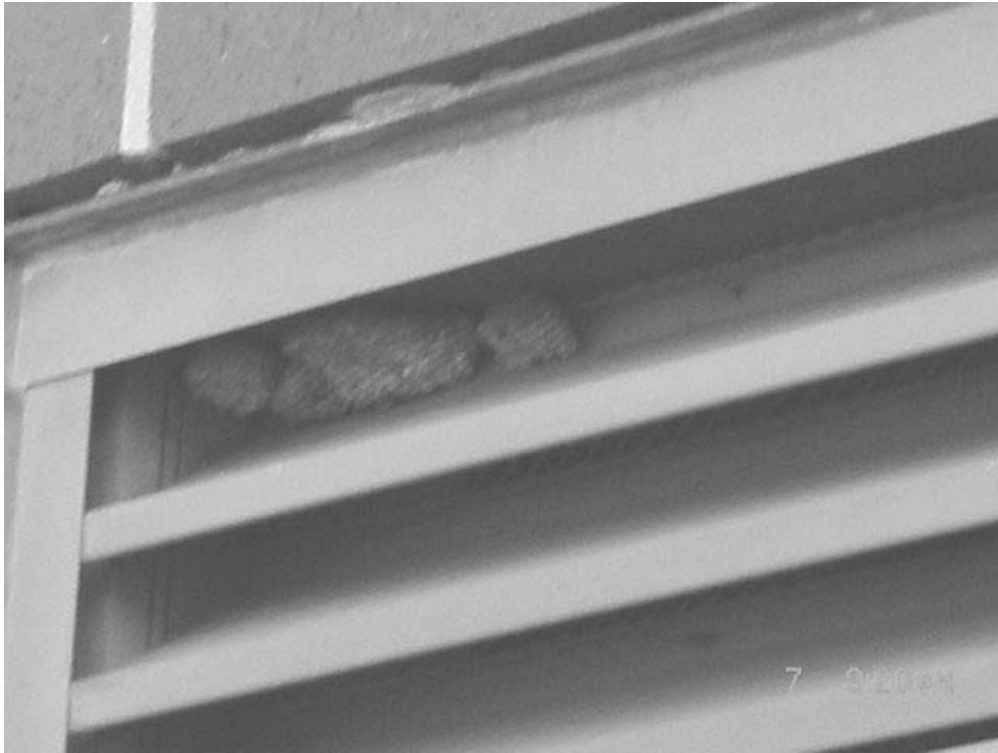
**Picture 12**

Finally, a number of bee/hornets nests were observed around the perimeter of the building, some near univent air intakes (Picture 12). These nests should be removed in a manner as to not introduce pesticides and/or insects into the building. Under current Massachusetts law that, effective November 1, 2001, the principles of integrated pest management (IPM) must be used to remove pests in state buildings and grounds (Mass Act, 2000).

**Hornet/Bees Nest in Univent Air intake**

13. Remove nests in a manner consistent with the principles of IPM (Mass Act, 2000). An IPM implementation booklet is available from the Department of Agriculture:  
[http://www.mass.gov/agr/pesticides/publications/IPM\\_kit\\_for\\_bldg\\_mgrs.pdf](http://www.mass.gov/agr/pesticides/publications/IPM_kit_for_bldg_mgrs.pdf).
